BABYLON PACKAGING

Babylon Trims Ltd., Kandi Boilarpur, Hemayetpur, Savar, Dhaka, Bangladesh.

INTRODUCTION

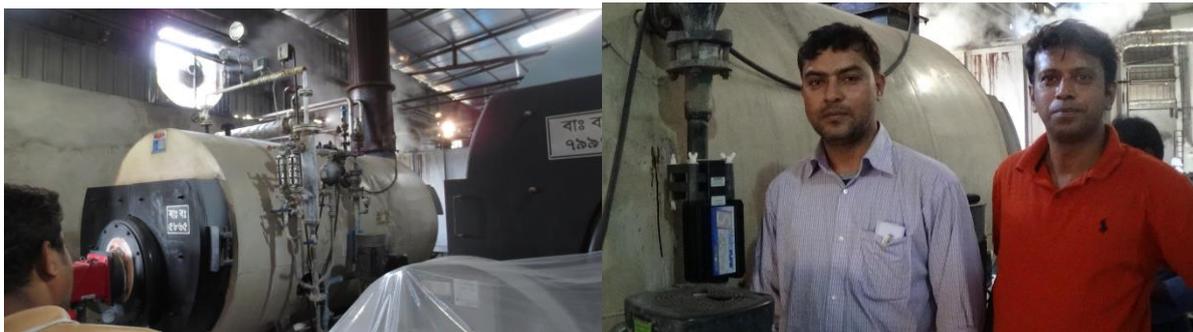
The water feeding the steam boiler was treated by both a softener and antiscalant. The softener required 400kgs of salt per month, costing 7,200 Bangladeshi Taka or around \$90, per month. The amount of antiscalant used was approximately 16.5kgs per month, costing 8000 Bangladeshi Taka or around \$100, per month.

Esprit de Corps, official distributors of Hydroflow for Bangladesh, installed a Hydroflow S45 unit in February 2017, on the boiler cold water inlet after the high pressure pump. The softener and the antiscalant treatment were both stopped.

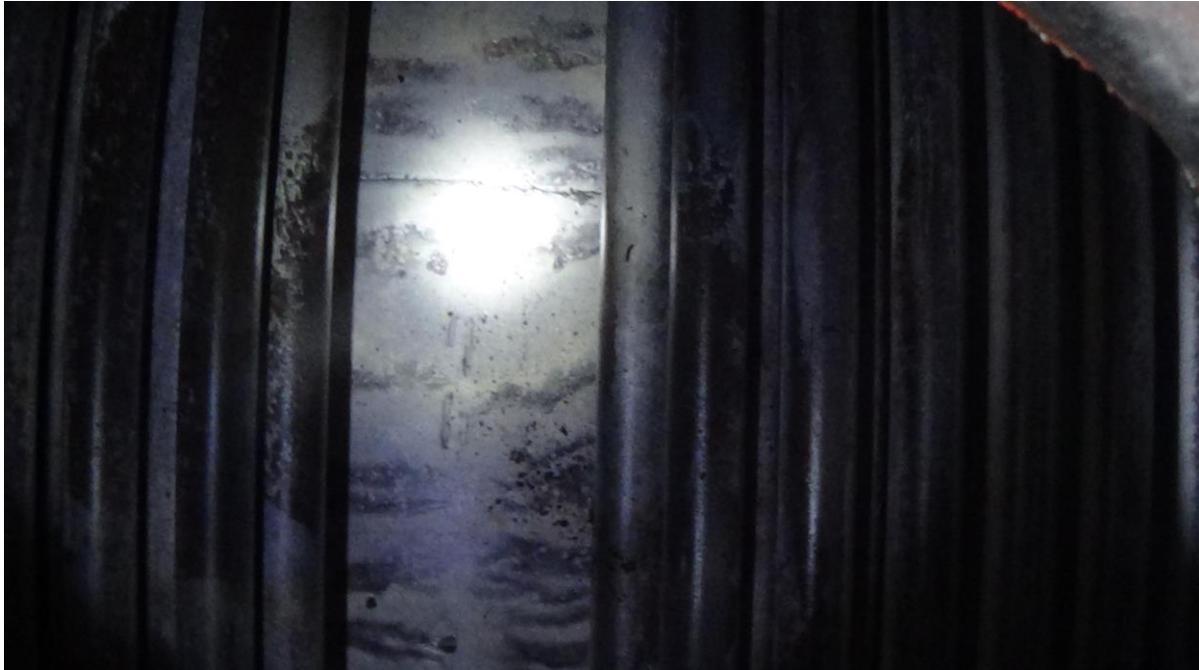
Boiler tubes and shell

The boiler tubes were found to be completely clear of scale – cleaner than they had been immediately after cleaning, indicating that the unit had removed existing scale. The surfaces of the boiler shell were also clear of hard scale, with just a fine powdery deposit remaining. There was no need for the difficult descaling that previously took 3 days.

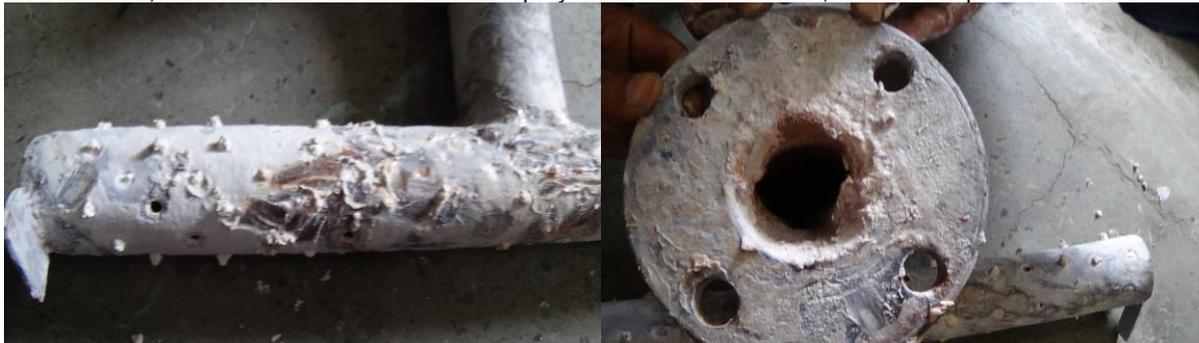
The T header, where the water from the inlet is sprayed onto the boiler tubes, was also inspected.

The T-Header was coated, inside and out, with a soft putty-like substance which can easily be wiped off by hand, as can be seen in the images above. This putty is composed of fine calcium carbonate crystals formed by the action of the Hydroflow unit. Also noticeable are several separate hard chunks of limescale which have become caught in the holes of the T-header. These chunks are pieces of old scale from the inlet and other parts of the piping system which the Hydroflow has caused to detach. These deposits are not bonded to the header and so are easy to remove by hand without chemicals. Once the system has been fully cleared of old scale, there will be no such deposits in the future.
