# HYDROCOFFEE

## Civitavecchia Fish Farm, Civitavecchia, Rome, Italy

This case study describes an application on a fish farm in Civitavecchia, near Rome. The main purpose of the application was to replace the UV treatment used to control Bacterial and Viral infections in the fish with treatment by Aquaklear. The Farm operates on sea water.

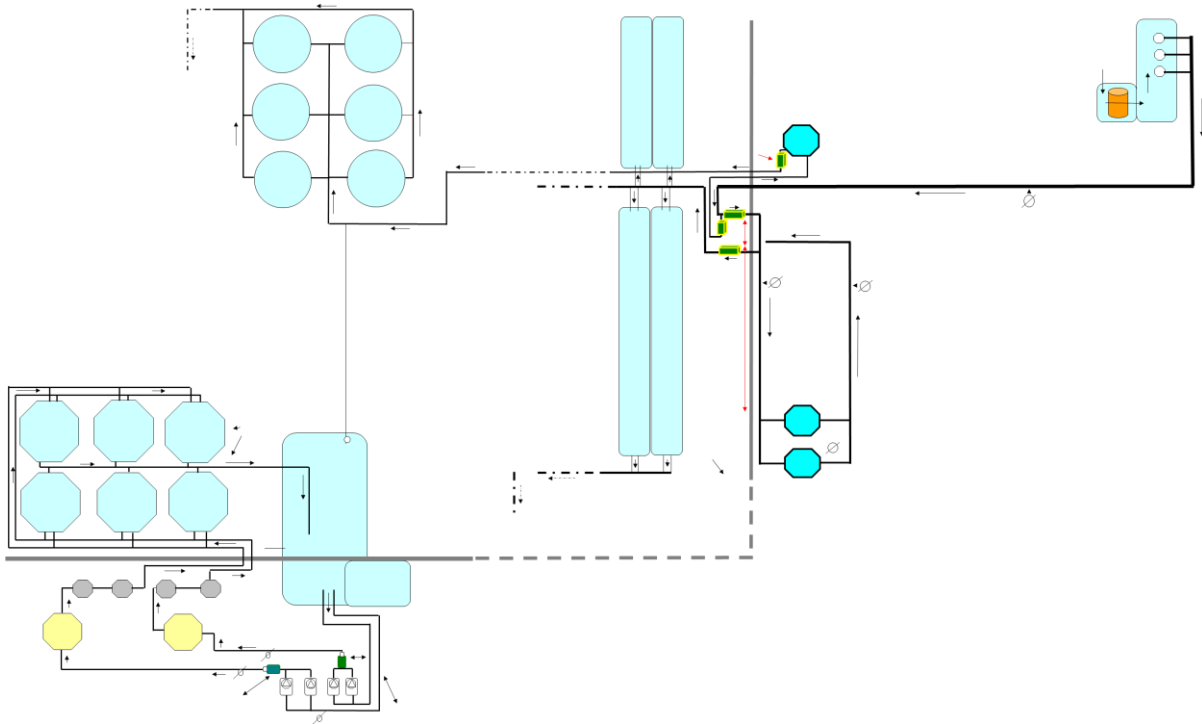
Figure 2: Diagram showing the location of some of the units

All of the incoming water on Route 1 was treated by a high power UV unit. Several other UV treatment devices were installed around the plant.

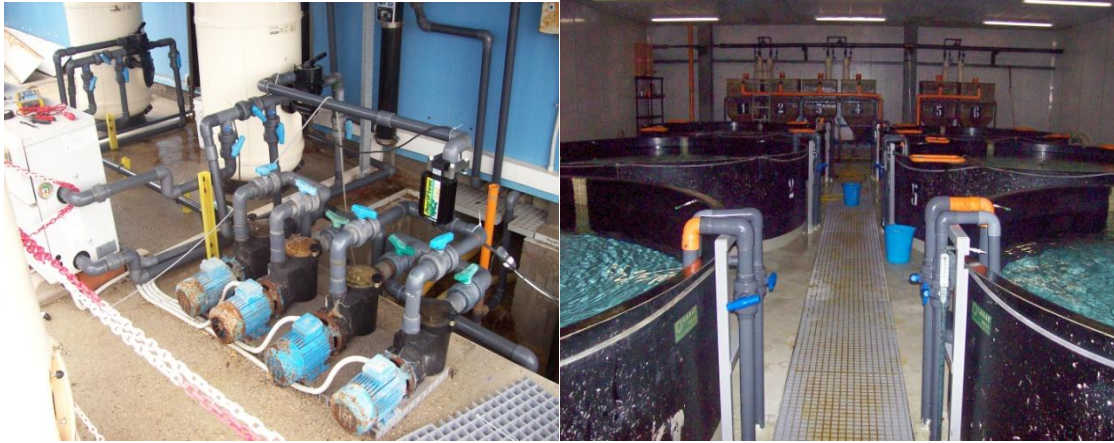
Figure 4: The Pump set feeding the hatchery, with an Agriflow A60 installed (left), and the breeding tanks (right)

The Hatchery was on a closed circuit loop which consisted of the six large hatchery tanks, two filters, two pump sets and storage tanks. The circuit was treated by four UV units. In Phase 1, this treatment was replaced by two Agriflow A60 units, placed before the filters.

The farm had six breeding tanks on an open circuit. Two Agriflow A100 units were installed, one before the filter and one after. The unit before the filter flocculated any particles to help the filter remove them, and the unit after the filter killed any microbes that had built up in the tank.

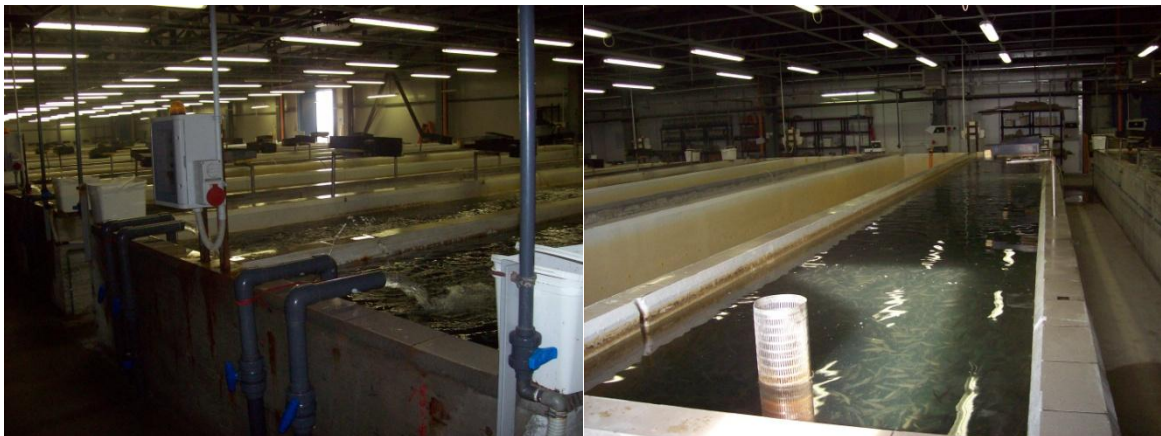
Figure 5: Tanks in the main hall

In order to treat all of the water incoming to the large main hall, two large sand filters were added in place. The large volume of water required very large pipe sizes (DN 300mm), and so the water was treated by two Custom Agriflow A300 units that were placed one on the entrance and one on the exit of these filters, in order to flocculate material and to kill bacteria.
