DOMESTIC HOT WATER TANKS

RED WOOD INN & SUITES ALBERTA – 2011

Inspection Report After HydroFlow Installation

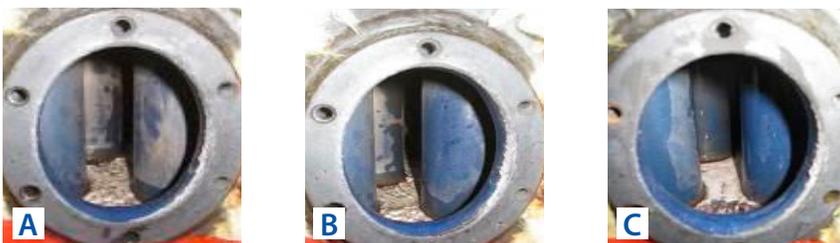
At a six month inspection, the hot water tank flues (A) were scale free but covered by light talc (an expected result of breakdown of existing limescale). The talc easily wiped off with a cloth (B and C).

Pictures A and B show the bottom of the tank covered with a thin layer of loose scale (~one-sixteenth of an inch after 6 months without flushing out or cleaning – substantially reduced from maintenance reports of one-inch of scale every 6 weeks). After vacuuming, the bottom of the tank just above the access opening is scale free (C). One sees a thin layer of scale adhered to the bottom of the tank, which is expected to breakdown over time and wash away. During inspection, the tank was flushed twice from the top. As no additional scale flushed out, one may assume that the upper regions of the tank are scale free.
