The Waianae Store. Ice Machine

Case study: 165 days

Goal: Significantly reduce scale build up in Ice machine

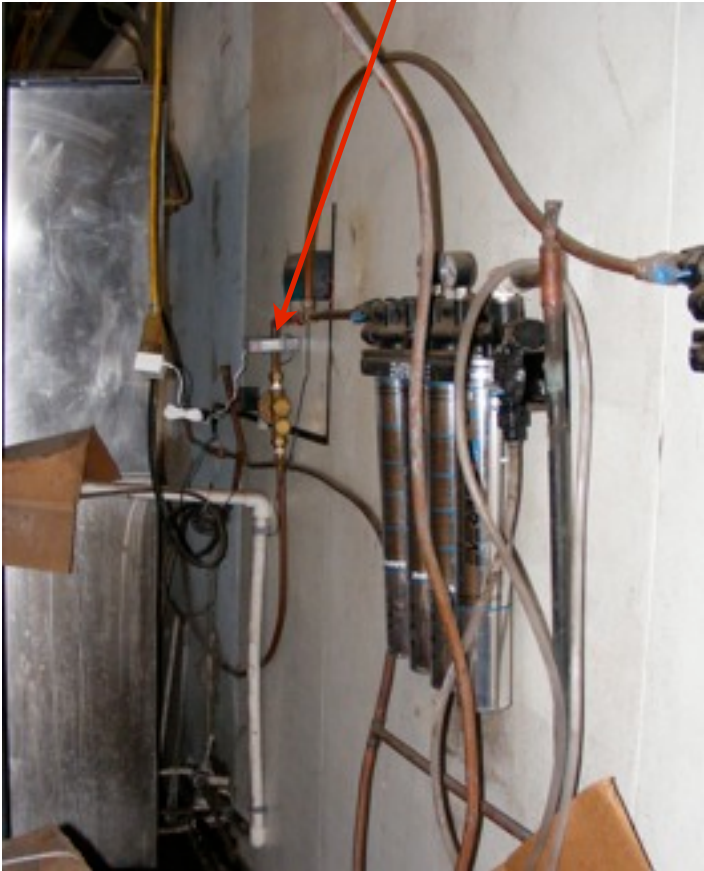
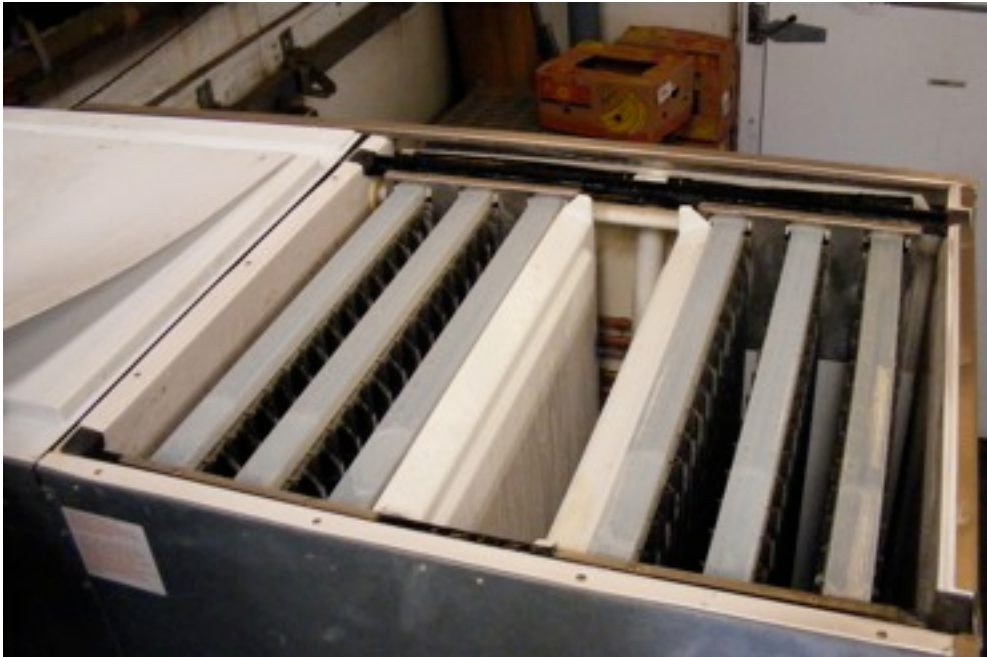
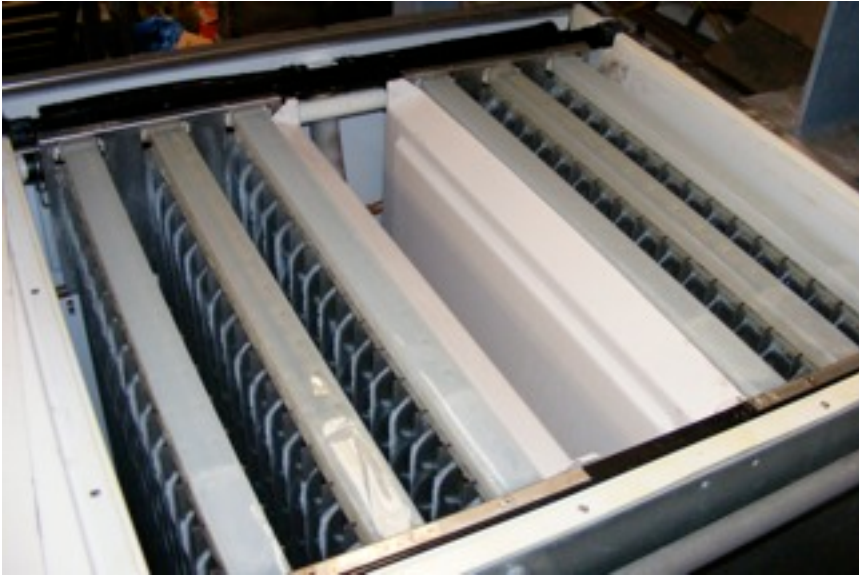
Limescale build up, before HydroFlow, formed typically in 3 months even with the water filtration. After the installation of HydroFlow there is almost no scaling, only a soft gel paste which is very easy to remove.

Limescale build up reduction: The increased performance was noticeable within 20 days.

Maintenance: The property conducts quarterly cleaning and inspection regardless. The ice machines quarterly maintenance and cleaning is taking 1/6 of the time or less, which is a substantial savings in labor. Hydroflow will improve the performance of the equipment through out the quarter, and reduce maintenance.
