July 14, 2014

On December 20, 2013 I installed a HydroFLOW S38 water treatment unit on a steam generator at the Santa Fe Indian Hospital. This unit was installed to evaluate the effectiveness of HydroFLOW in preventing and reversing scale accumulation in the boiler and on the heating elements. This was a trial being observed by the Indian Health Services of New Mexico to qualify HydroFLOW for further consideration for use on the boilers, cooling towers and other equipment at their facilities throughout New Mexico

Steamer

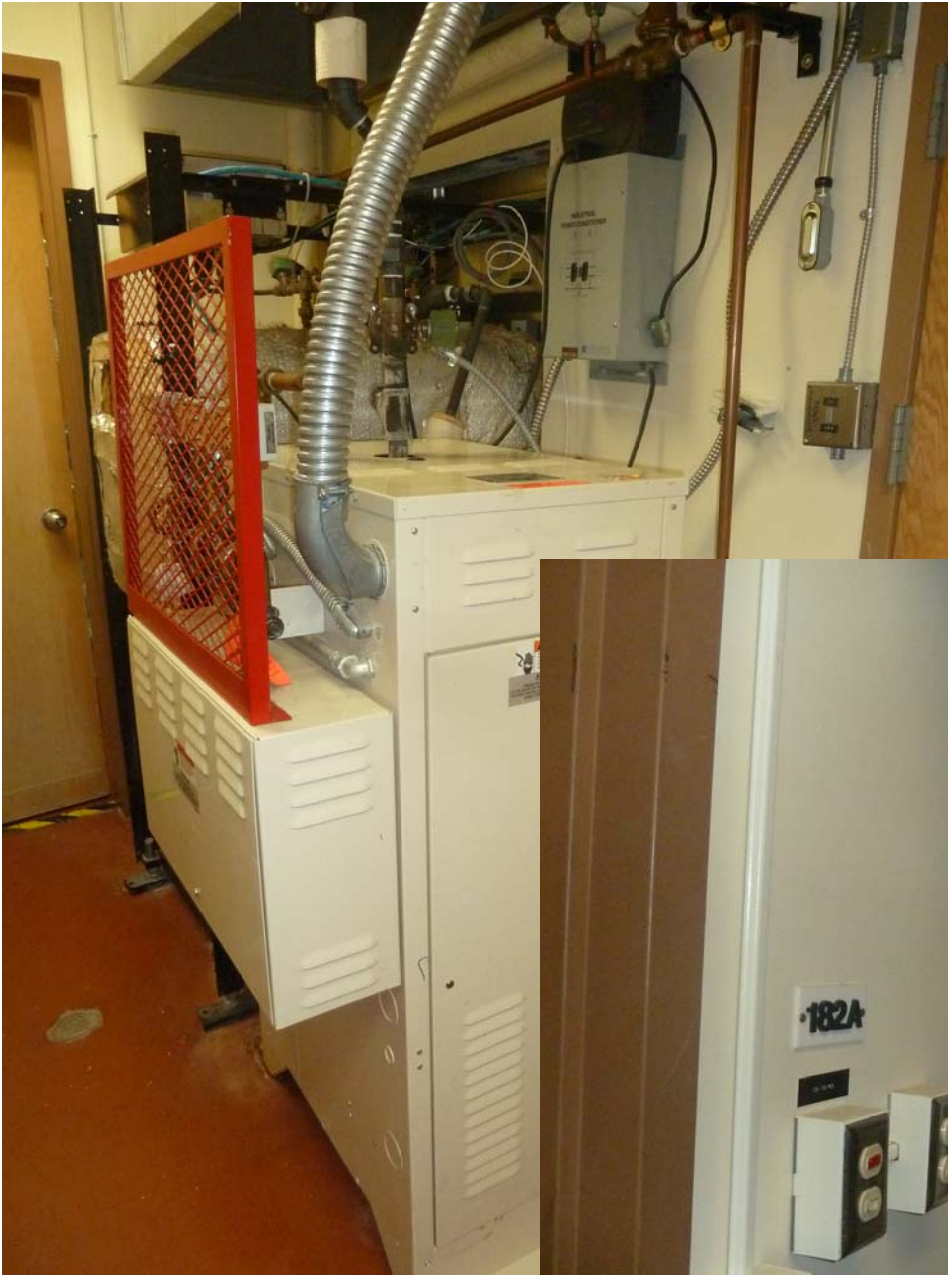
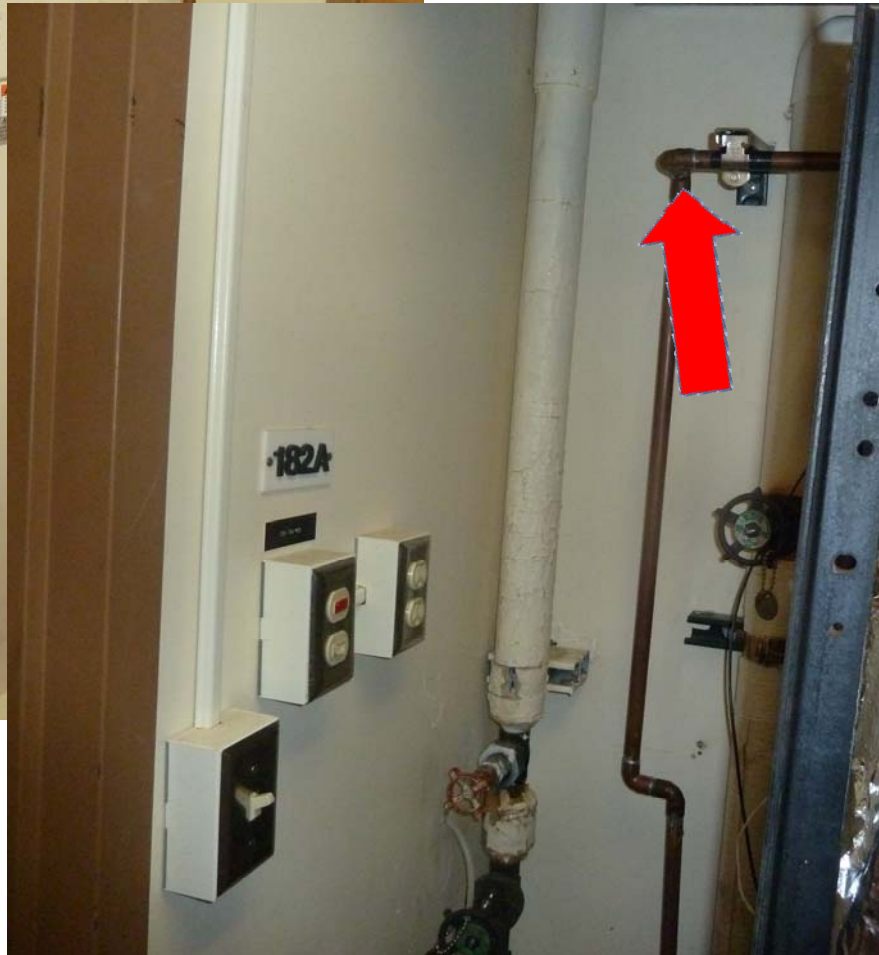
Installation Point for HydroFLOW S38 Unit
The S38 *HydroFLOW* water conditioner includes a surge protector and plugs into a standard 115 VAC outlet

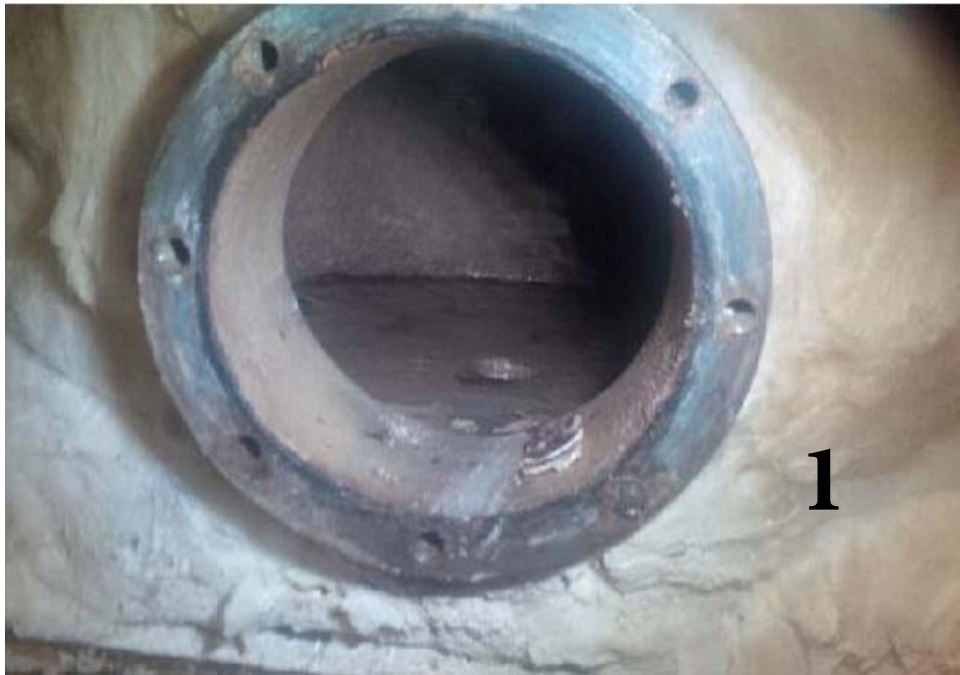
This is what I sent to my Colleagues. The first picture is of the bottom of the Boiler, as you can see no scale at all and blow down pipe is visible. Second picture is the port for the second bundle of heating elements, also no scale build up on top of boiler. The other 2 pics are of the heating element bundles. Normally these are so full of scale that it would ground itself out and we would have to replace it, but as you can see not a drop of scale. It is unbelievable that it works this good. So your product already paid for itself. Thanks.
