HYDROCOFFEE

Hatchery and Research Centre for Marine Species, Rosignano Solvay, Livorno, Italy.

This case study describes a fish hatchery which also doubles as a research centre. The hatchery takes in sea water which is distributed to various tanks containing the fish.

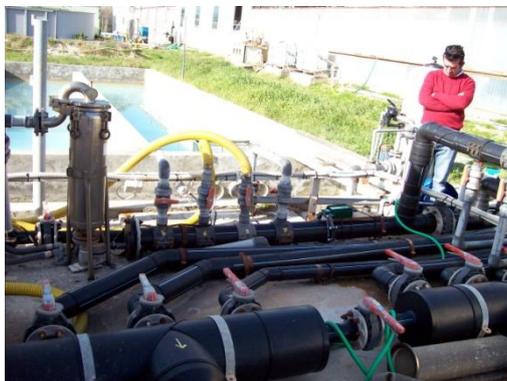
Figure 2: An Agriflow unit installed on the incoming water to the whole plant.

In 2007 Hydrocoffee installed Agriflow units to protect the plant, one on the main incoming water, and several installed at various locations around the plant.

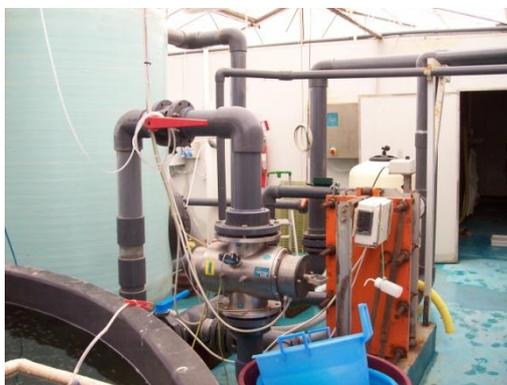
Figure 3: An Agriflow A100 unit installed before the water is transferred to the main fish tanks.

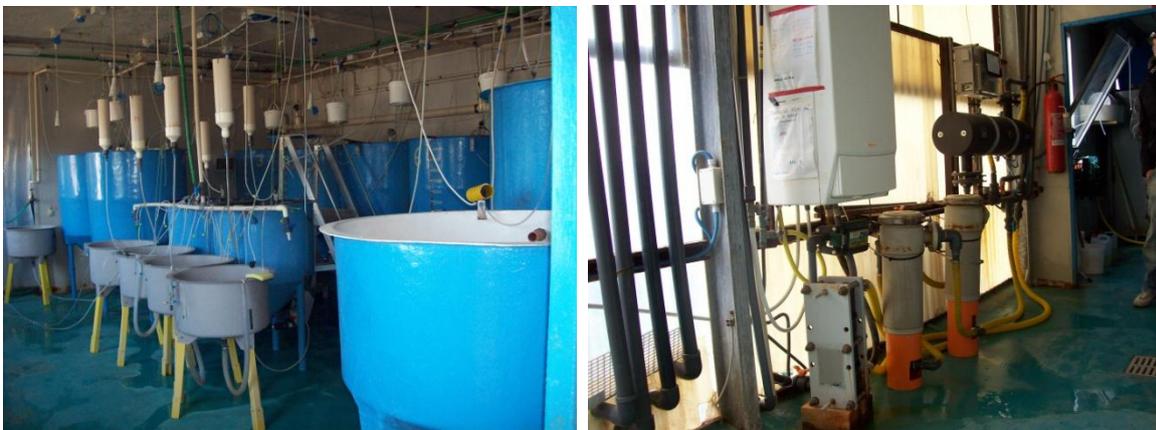
Figure 5: In these tanks (Right), new-born fish are placed to begin their growth. The Agriflow unit (right) protects the fish against bacteria, and also protects the heat exchanger against limescale.

As well as protecting the main fish breeding tanks, the Agriflow units were also installed to protect the culturing tanks used for the new-born fish (which was mostly closed-circuit) and for protecting the external water storage tanks.

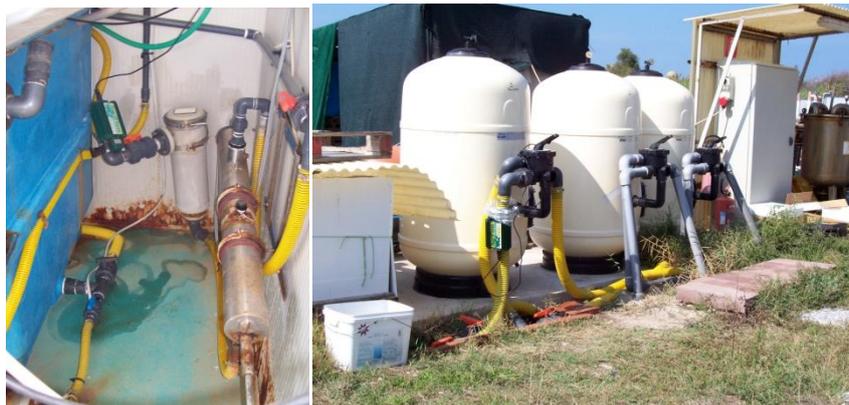
Figure 6: External water storage tanks also had their UV protection replaced with Agriflow.

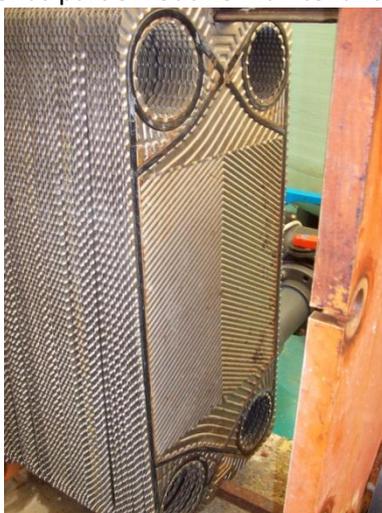
Figure 7: A heat exchanger protected against limescale by Agriflow. Instead of twice-yearly acid washes, the exchanger is hosed down once a year as part of routine maintenance.

The heat exchanger shown had problems of scale every six months and had to be completely disassembled and washed with acid. Now, with the installation of Agriflow, it is only opened once a year and washed with a jet of water as part of routine maintenance.
