HydroPath Holdings Ltd

## CASE STUDY DETAILS

### HOTEL BARCELO CALA VINYAS

Location	Mallorca ( Spain )	Date of first Inspection:	20/06/2013
Application	Hot water system	Date of Second Inspection:	27/07/2013
Purpose of installation:	To reduce hard scale		
Installation date:	20/06/2013

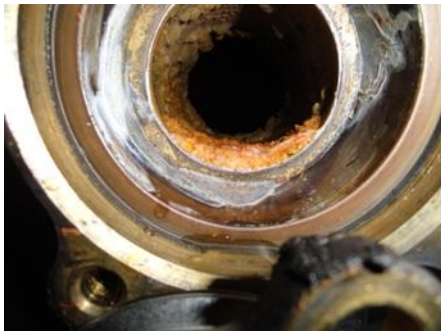
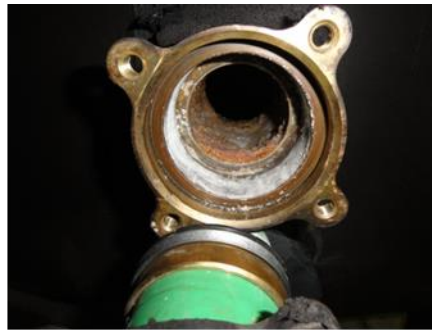
Before

A Hydroflow P-100 was installed on the pipe to the boiler, just before the calcification that is observed.

1. In the 'before' pictures a layer of soft scale can be observed and this illustrates that the descaling process had started.
2. In the 'after' pictures it can be seen that the pipes have much less limescale on them and it is finer scale.
